The reinforcement of foundation in a building with 7 floors after 20 years

In this context, the present work aimed to investigate pathologies that occurred in a 7-floor building in the city of João Pessoa/PB, which occurred 20 years after its construction, as well as to expose the proposed reinforcement elaborated for the foundation. In this study, the monitoring of settlement that was carried out before and after the reinforcement was also presented, to verify the stability of the foundations.

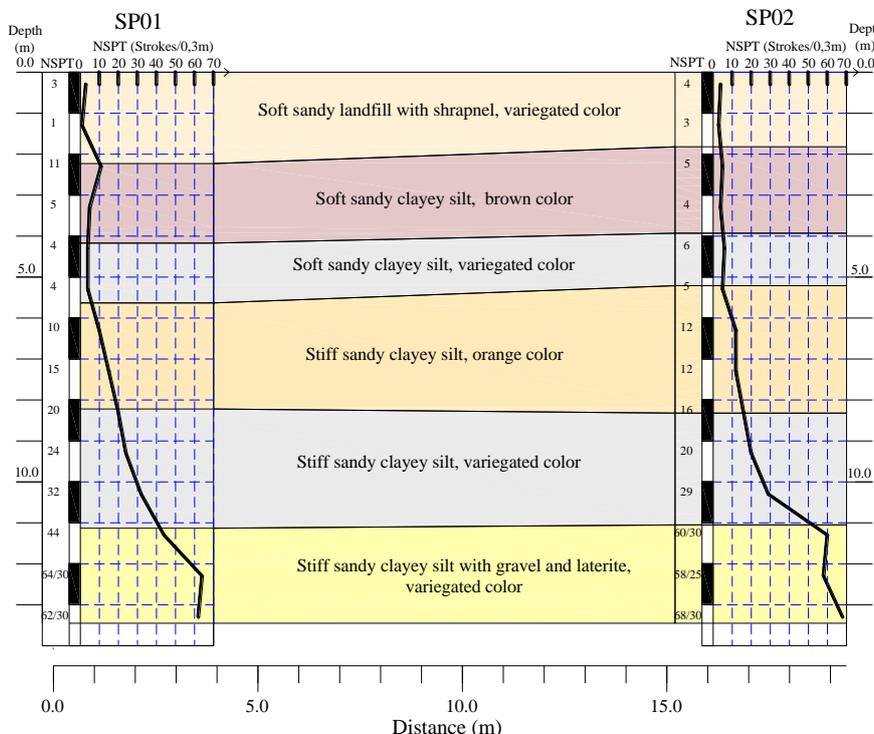
SPT tests were carried out in the study area, from these probing tests, it was possible to identify the soil stratigraphy. As shown in Figure 5, the soil is formed by the following layer arrangements: sandy embankment with shrapnel, soft, of variegated color (0.00 to 1.80 m); sandy clay silt, soft, light brown color (1.80 to 3.90); clayey sandy silt, soft, of variegated color (3.90 to 5.20 m); clayey sandy silt, stiff, orange (5.20 to 8.30 m); clayey sandy silt, hard, variegated in color (8.30 to 11.00 m); and clayey sandy silt, with gravel and laterite, hard, variegated in color (11.00 to 13.45 m). It should be noted that the water level for the depth probed was not found.

Figure 5 – Geotechnical Profile

Thus, the occurrence of building pathologies can be attributed to this water leakage that happened in the building's vicinity, which caused the ground to flood and consequently reduced the bearing capacity, harming the building's structure. The geotechnical profile verified the existence of an embankment layer of approximately 2 meters; this porous material in the surface layer of the land may have contributed to the percolation of water affecting the structural elements on the front facade of the building. Given these considerations, the occurrence of pathologies in the studied building can be attributed to the leaking of the cistern that occurred years after the construction.

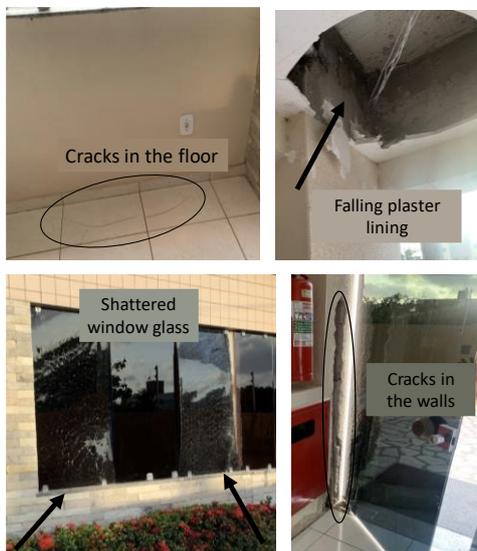
The building under study is a 7-story residential edifice that began to appear visible pathologies after 20 years of use. Pathological manifestations were observed in the internal and external environments of the building, as well as in some structural elements. In Figure 6 some pathologies identified in the building are presented, one can verify the occurrence of cracks in the floor, cracks in the walls, falling plaster lining, and shattered window glass. Cracks were also confirmed in the structural elements (pillars and beams) as shown in Figure 7.

Figure 6 – Pathologies presented in the external elements

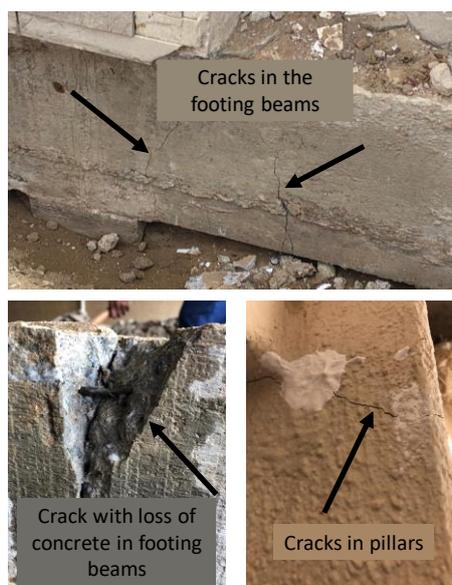
Figure 7 – Pathologies presented in the foundation elements

Based on the analysis of the problems observed, it was verified that the P4 pillar presented damage to its structure in a more critical way, with a greater amount of cracks and greater damage to the footing beams connected to it. Thus, it was proposed to carry out the reinforcement of the foundation of the P4 pillar, with the execution of micropiles joined by employing capping blocks connected by beams.

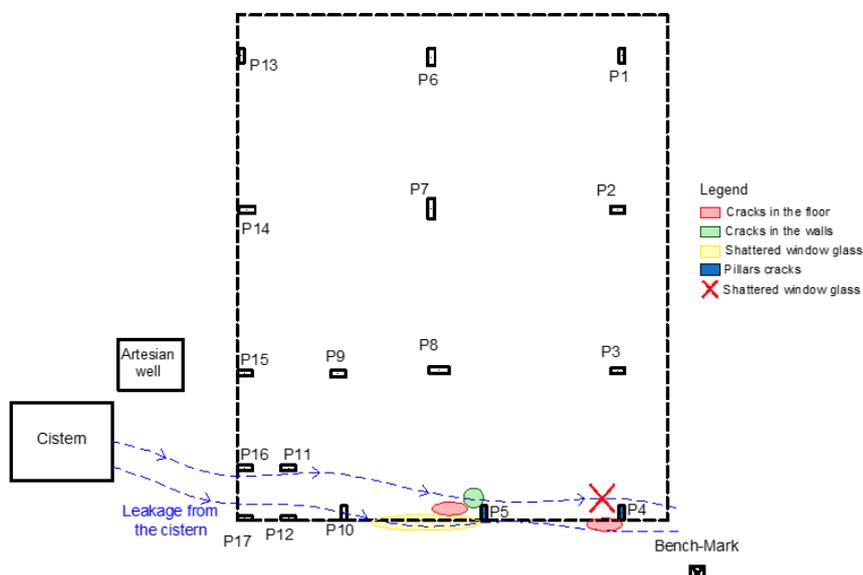
According to reports from residents of the condominium, the pathologies started in September 2020, in the same period that a leak was identified, from the cistern installed next to the building. Figure 8 shows the location of the cistern, the simulation of the leakage, and the places where pathologies were identified, it can be seen that the pathological manifestations were concentrated on the front facade of the building.

Figure 8 – Location of the cistern that had leaks, and location of pathologies

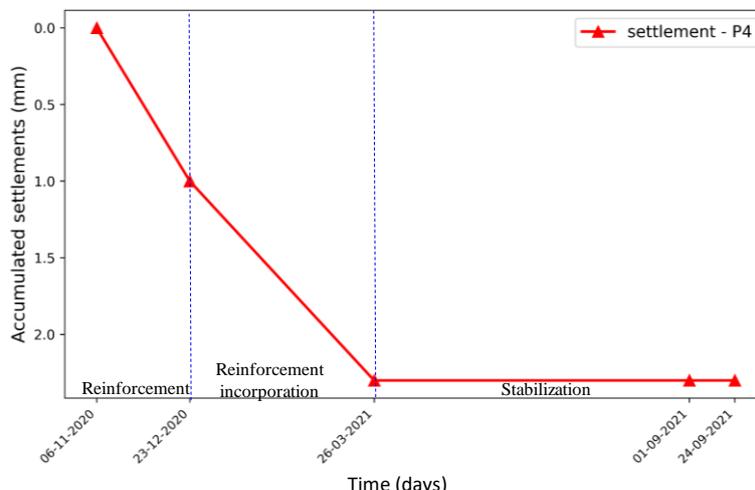
Figure 12 – Settlement suffered by the P4 pillar

The reinforcement of the P4 pillar was started on 12/14/2020 and ended on 12/22/2020, thus, the first measurement was performed before the reinforcement, on November 6th, and the second measurement was performed on the day after the completion of the booster, on December 23, in the interval that includes the booster performance, a settlement speed of 21.28 μ /day was verified.

From the subsequent measurement (26/03/2021), there is a decrease in the settlement speed, with a value of 13.98 μ /day, this stretch comprises the period of incorporation of the reinforcement, in which there is the redistribution of loads on the pillars. Finally, two measurements were performed in September 2021, one year after the occurrence of the leak and more than 5 months after the reinforcement was performed, considering the results, it was found that the settlement of the P4 columns has stabilized.
