The Reliability of the Dynamic Load Test to Detect Pile Damage

Daniel Kina Murakami

Benaton Specialist, São Paulo, Brazil, daniel.murakami@benaton.com.br

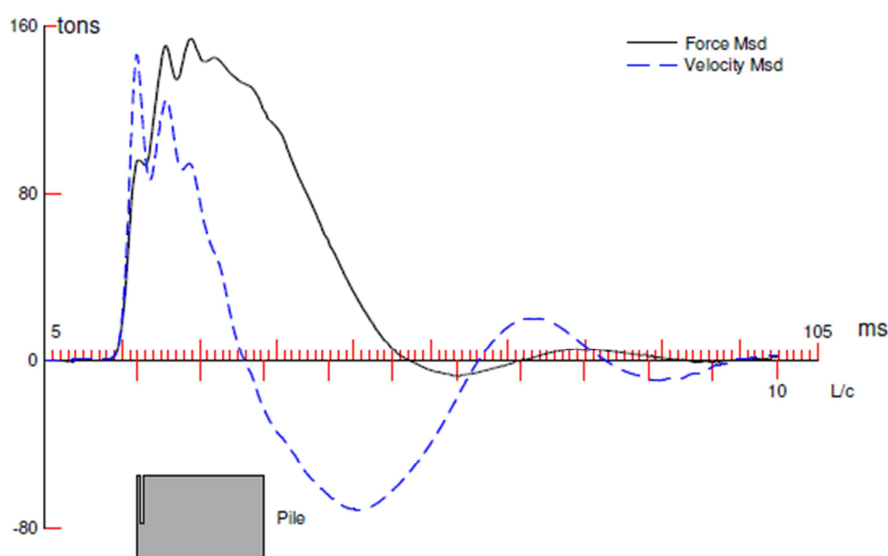
Figure 1 shows the force and velocity signals collected in a 29.5-square precast pile (30m depth floating pile). It is observed that the velocity increased sharply relative to the force before the $2L/c$ time, which is an indication of pile damage. Furthermore, a 6m-element of precast concrete pile was welded to the installed pile, allowing the execution of the Dynamic Load Test (DLT). In addition, the pair of sensors was attached to the pile 1.5m above the welding area. Figure 2 shows that the welding was not perfect because part of the cross-sectional area of the installed pile was damaged.

Figure 1. Force and Velocity signals from a 29.5cm square pile

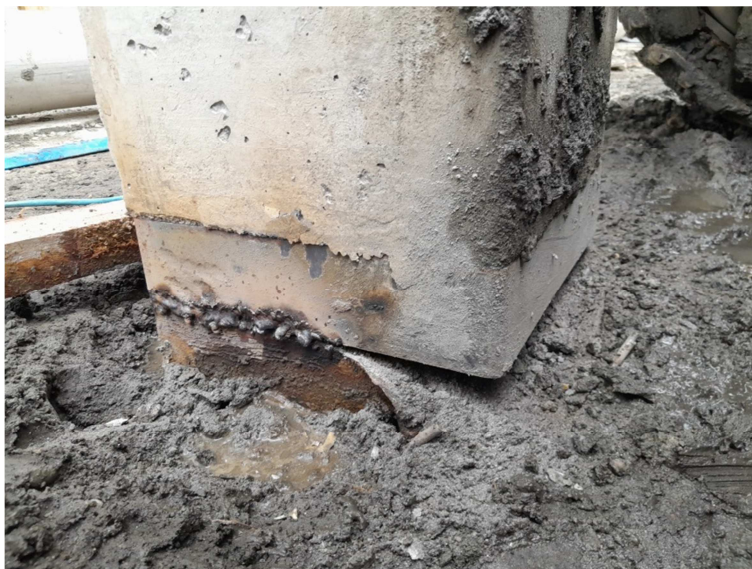
Figure 2. The welding area of the 29.5cm-square pile

Due to the welding problem, it was expected that the PDA would indicate damage on the pile at this position. The CAPWAP analysis was performed, and it indicated an impedance reduction of 57%. This magnitude of pile impedance reduction would consider that the pile was broken, but the pile cap would be installed below the damaged area. Then, this damaged area would be removed to install the pile cap, indicating that the pile could support the loads from the structure. Figure 3 shows the load vs. displacement curve of the CAPWAP.

These damages were close to the ground level. Furthermore, in the first case study, the pile cap would be installed below the pile damage. Then, this damaged area would be removed to install the pile cap, indicating that the pile could support the loads from the structure. It was possible to reconstruct the pile in the second case study, although it would be considered slight damage.

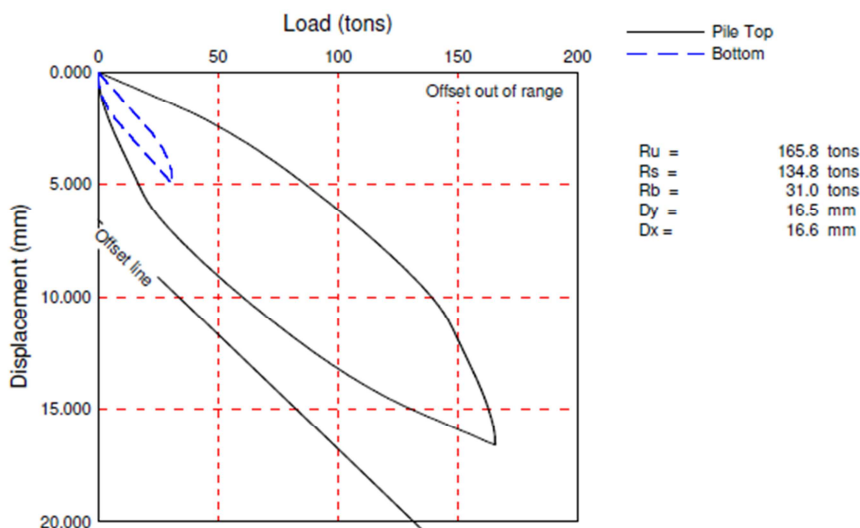
Figure 3. Load vs. displacement of the CAPWAP

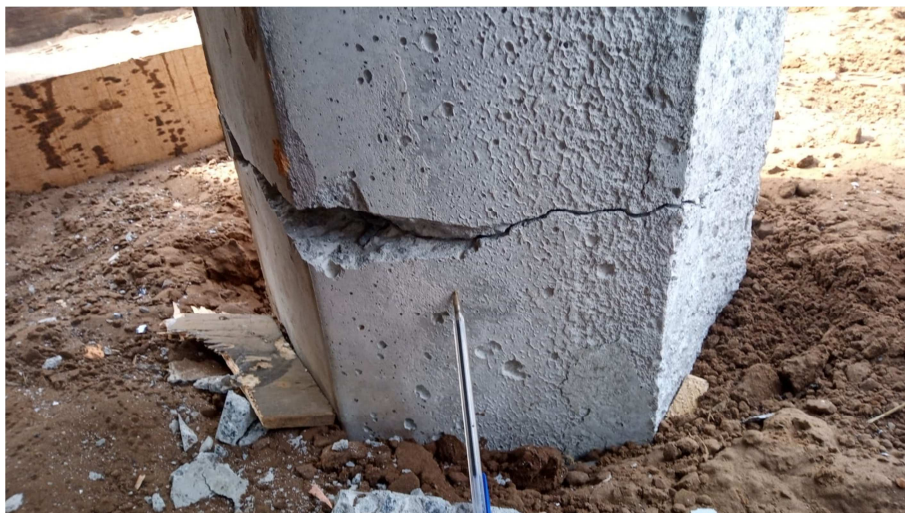
Figure 4 shows the force and velocity signals collected in one of the piles. It is observed that the velocity increased sharply relative to the force before the $2L/c$ time, which is an indication of pile damage. Furthermore, the PDA was used during the pile installation for monitoring the compression and tension stresses. This procedure helps select the ideal drop height of the hammer, avoiding damage to the piles (Murakami and Cabette, 2014, 2022). Although the stresses along the pile were acceptable, damage about 5m below the sensors was observed. When it happened, the damage was above ground level, as shown in Figure 5.

Figure 5. The damaged area of the 45cm-hexagonal pile

Due to the damaged area observed above the ground level, it was expected that the PDA would indicate damage on the pile at this position. The CAPWAP analysis was performed, and it indicated an impedance reduction of 23%. This magnitude of pile impedance reduction means that the pile has slight damage. Once the damage was close to the ground level, it was possible to reconstruct the damaged area on the pile, although the magnitude of the damage was acceptable. Figure 6 shows the load vs. displacement curve of the CAPWAP.

The 4-ton drop hammer continued the application of the blows at the pile top, aiming to reach the design depth. Moreover, monitoring pile driving allowed us to successfully install the deep foundation to the design depth.

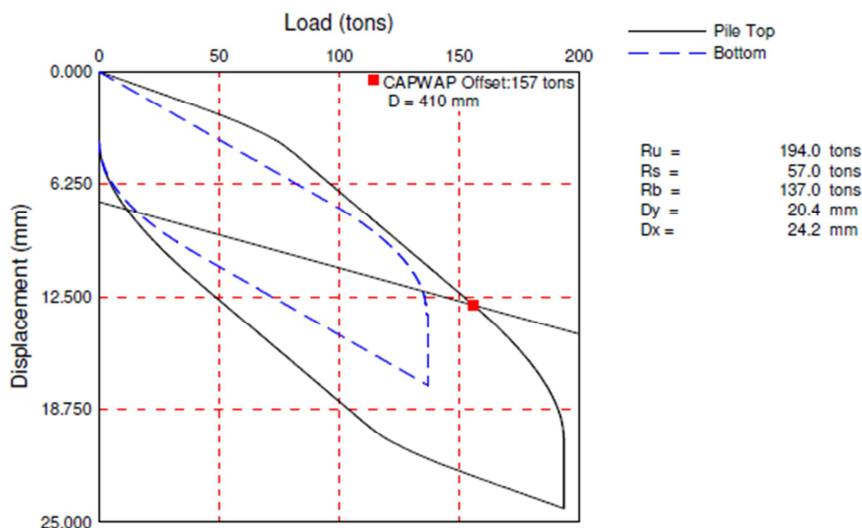
Figure 6. Load vs. displacement of the CAPWAP
