Root Piles Installed Through Heterogeneous Technogenic Layer Followed by a Residual Soil

ABSTRACT: The project site is an expansion of ETA Guaraú. The soil profile indicated a heterogeneous technogenic layer of different materials about 30.0 m depth, followed by residual soil. Therefore, the project required root piles with constant cross-sections embedded in the residual soil (36.0 m to 42.0 m depth). The first six test piles allowed the improvement of the drilling equipment, designed to work with compressed air and water simultaneously, overcoming obstacles such as bushing, rubble, and gravel, among others, which conceded the application of air strokes after filling the shaft. The depth of the piles was monitored by torque reading on the drilling rigs in constant advance. Besides, variations in the shaft friction distribution and cross-section along the shaft (mortar over-break rate) were observed due to the soil heterogeneity. Further, the collected signals from the integrity and dynamic tests were atypical and difficult to interpret, constituting an additional challenge due to the project's complexity, and each tested pile had its own identity. Moreover, the dynamic and instru

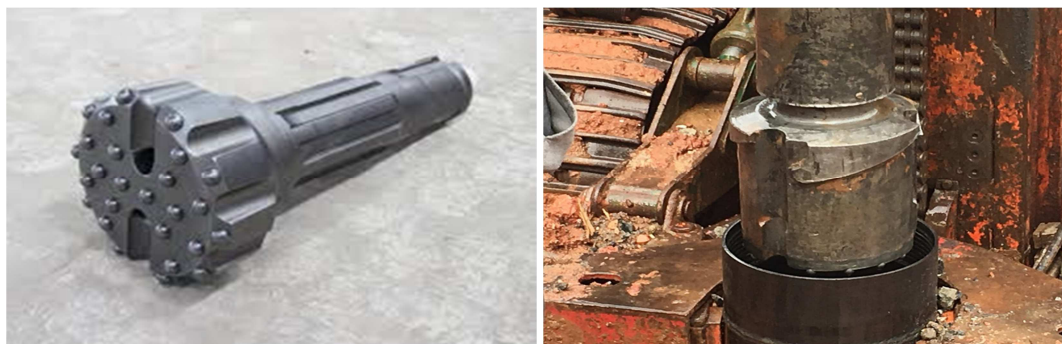
Due to the heterogeneity of the landfill (spoil area), and to avoid telescoping, the tool to be used should operate as a cutting and drilling tool with simultaneous water and compressed air. Thus, this tool was initially designed as a set consisting of an internal-mounted DTH hammer coupled with a cutting shoe (see Figures 1 and 2). This set was designed to maintain a maximum vertical impact stroke of 40 mm, similar to the standard bottom hammer (DTH - Down the Hole). The set had peripheral air outlets (similar to the DTH hammer) to prevent the mortar's choking during the piles' injection.

Figure 1. DTH hammer coupled with a cutting shoe (Saez et al., 2020)

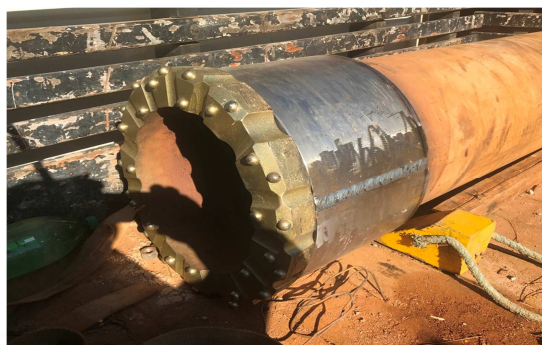
Figure 2. Last cutting tool used to install the root piles (Saez et al., 2020)

The cutting tool was further optimized by modifying the position of the tungsten bits (cutting) and the compressed air outlets, thus reducing soil plug incidents. An impact damping system was introduced, with a stroke of 40.0 mm, similar to the stroke of the DTH hammers used in conventional piles. When the stroke of the shoe exceeded these 40.0 mm, the tool was sent for grinding.

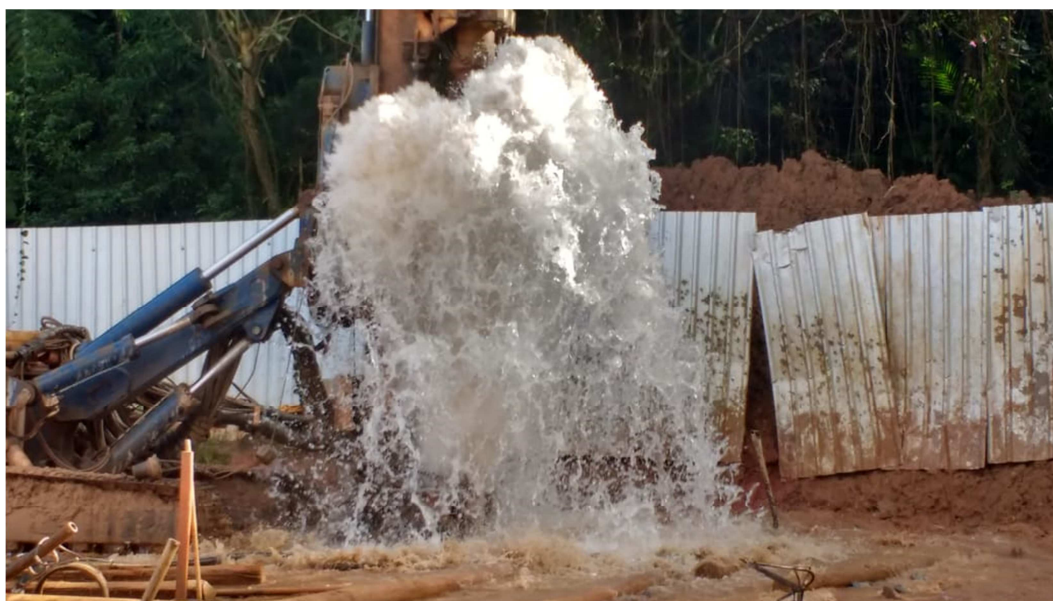
Artesian well during the drilling phase (Figure 3) and total water loss during the flushing phase were observed at this location. This problem was solved injecting a less dry mortar into the borehole and restart the pile injection at least 6,0 hours later.

Figure 3. Artesian well during the drilling phase

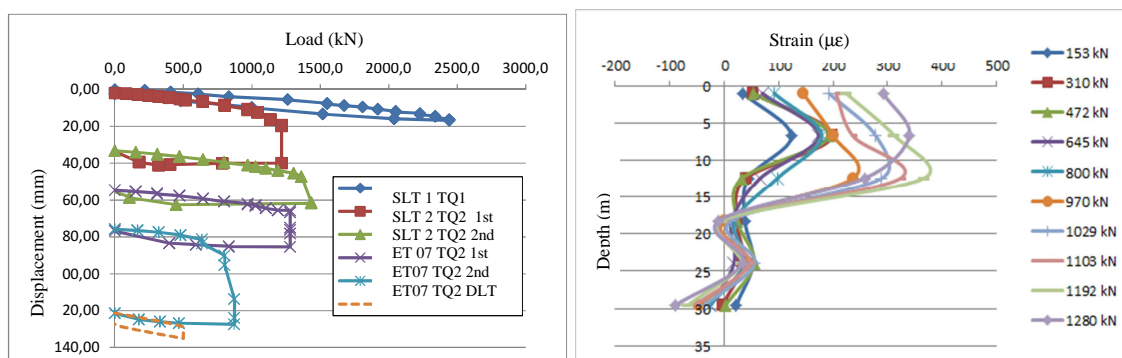
Figure 4a shows the graph of all SLTs and the result of the CAPWAP analysis for pile ET-07 TQ2. Figure 4b indicates the results obtained from the strain gauges installed in the pile ET-07 TQ2 for each load increment of the SLT, ranging from 153 kN to 1280 kN. A total of 6 strain gauges (S1 to S6) were installed at different depths. The following depths indicate where they were installed: S1: 1.0 m; S2: 6.7 m; S3: 12.4 m; S4: 18.2 m; S5: 23.9 m; S6: 29.5 m.

Figure 4. a) SLTs and DLT result of the pile ET07 TQ2; b) strain vs. depth of the 1st SLT in the pile ET07 TQ2

It can be observed in Figure 4b that the strain gauges indicated greater deformation in the landfill region (depth up to 30.0 m), with higher shaft friction between 12.4 m and 18.2 m, due to the greater difference in deformations between strain gauges S3 and S4. The result of this instrumented load test was essential for understanding the behavior of the piles subjected to axial loads and served as a basis for applying the Signal-Matching Method in the Dynamic Load Test (CAPWAP analysis).

In the CAPWAP analyses, the Signal-Matching technique proposed by Murakami (2015, 2018) was employed, aiming to model the soil-pile system in a way that presents higher shaft friction in the landfill region. A plug-on shaft (soil mass adhered to the pile shaft) with greater intensity was required at specific depths to apply the technique. Otherwise, the analyses would indicate a higher value of shaft friction in the first meters, diverging from the result of the instrumented static load test.

In SLT2-TQ2, there was an increase in the maximum load reached from 1,217 kN (1st test) to 1,435 kN (2nd test). In ET-07 TQ2, there was a decrease in the maximum load from 1,280 kN (1st test) to 872 kN (2nd test), with greater displacements from 30.72 mm to 52.67 mm. Subsequently, an Integrity and Dynamic Test was performed on this pile. The Dynamic Test showed a mobilized load of 500 kN and impedance reductions along the shaft, indicating structural damage. In pile ET-07, the pile set increased considerably (6 mm) for a drop height of 40 cm, while in the other tests, the pile sets ranged from zero to 2 mm, with drop heights

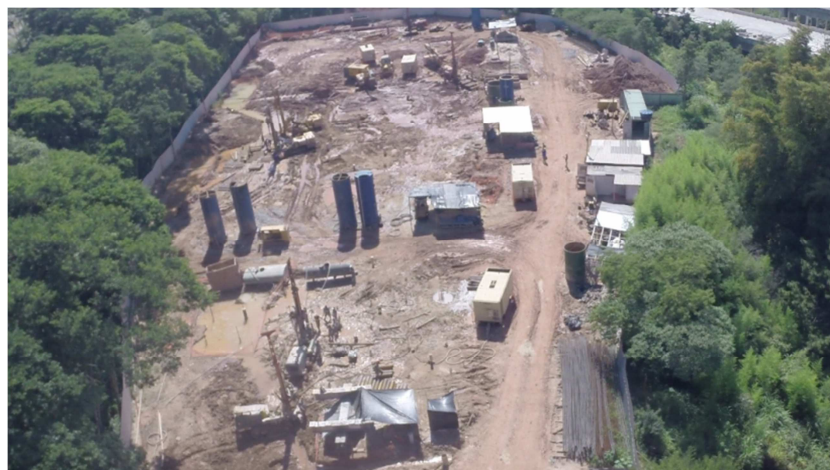
Figure 7 shows the project site at the beginning of the installation of the root piles. Figure 8 shows that the piles were successfully installed through the technogenic layer, reaching the residual soil where the toe of the piles was embedded, being able to support the design load of the Sludge Tanks.

Figure 7. Project site at the beginning of the installation of the root piles

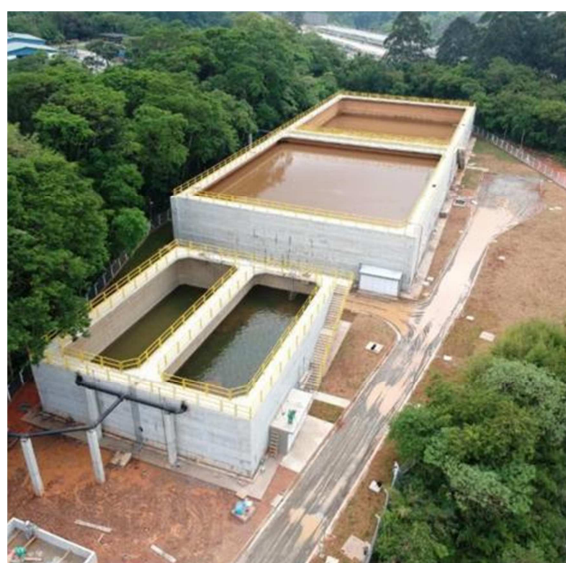
Figure 8. ETA Guaraú nowadays
